Rubble-Mound Breakwater Stability Tests for Pier J, Long Beach Harbor, California

Miscellaneous Paper CHL-97-4
May 1997

Final report

Prepared for Port of Long Beach
Long Beach, CA 90801-0570

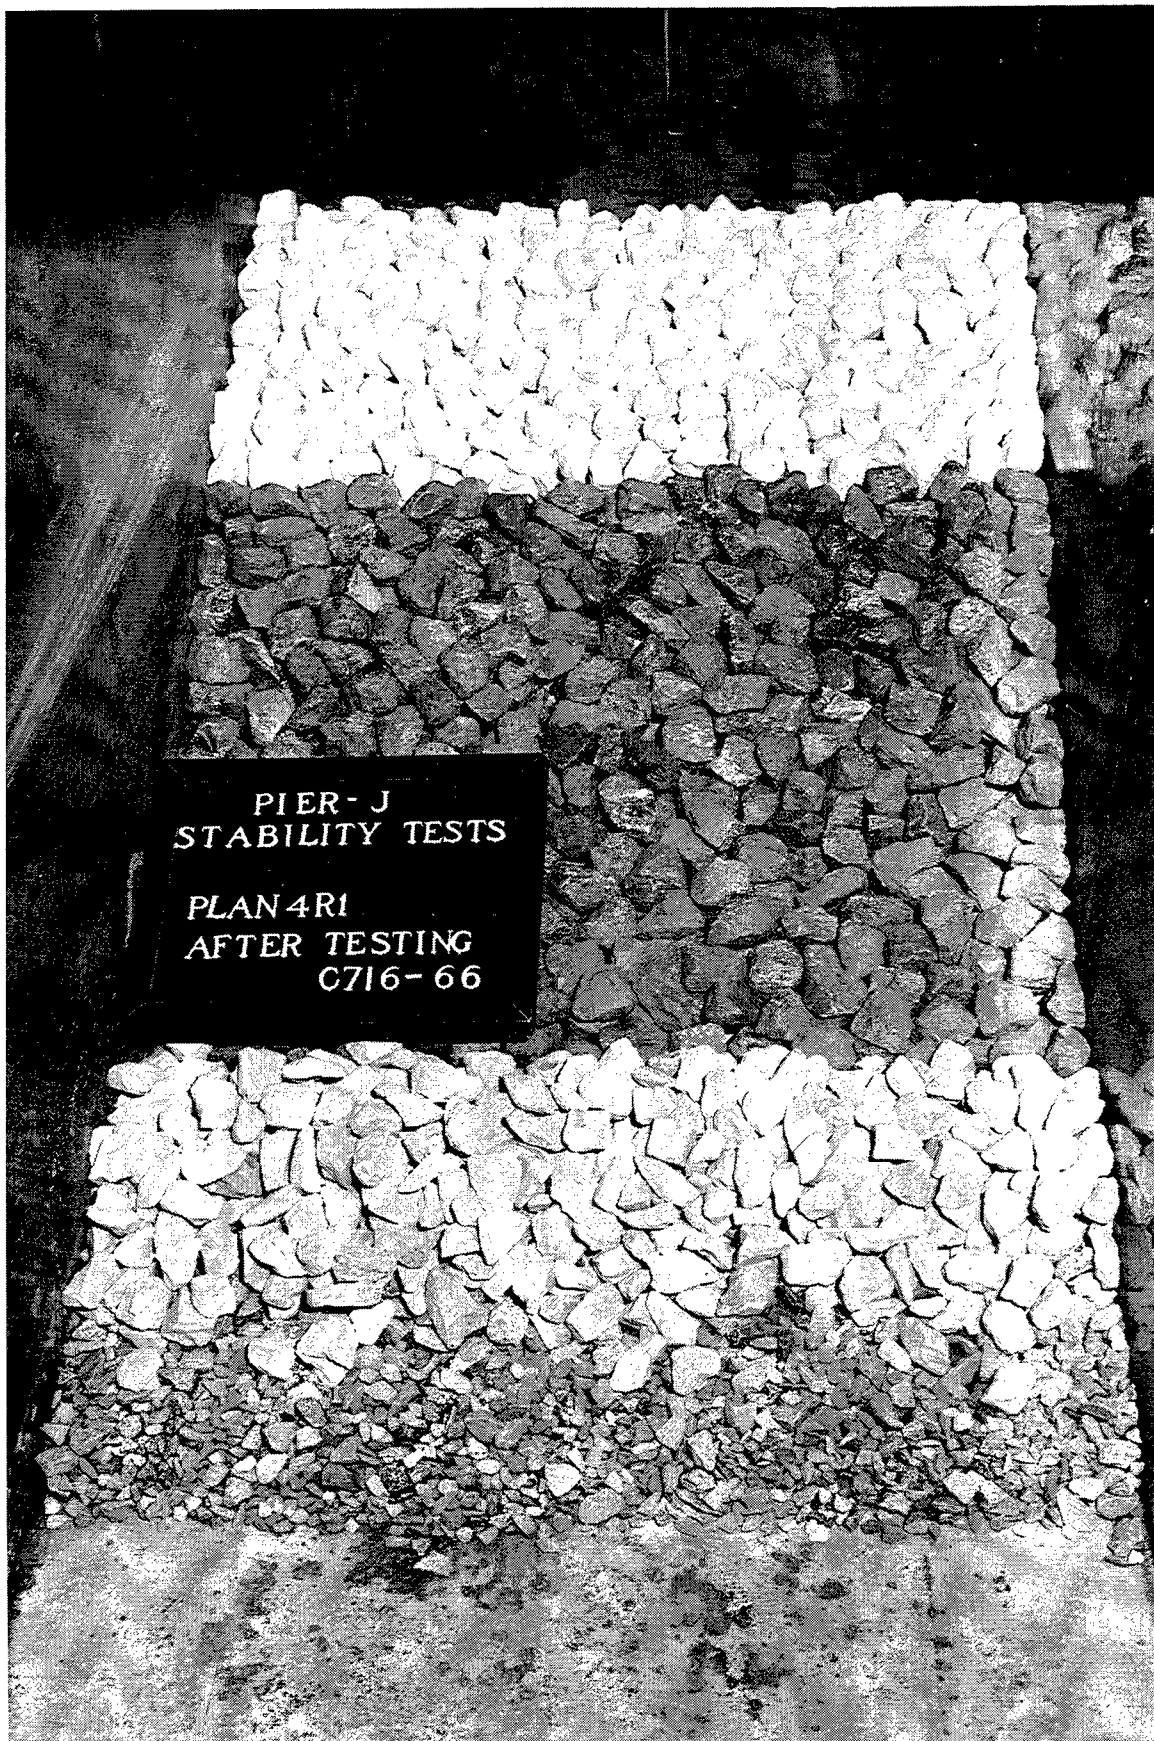
Photo 53. Sea-side view of Plan 4R1 after testing step 14 of Hydrograph 3A

Hydrograph 3A was the same as Hydrograph 3, except the 13-ft grouped waves were inserted (steps 15-18). No damage was observed during the first 10 steps. The 13-ft ungrouped waves tested in steps 11-14 caused minor (1.5 percent) landward damage. Photos 53 and 54 show the breakwater after step 14. As anticipated, steps 15-18 produced a moderate damage increase. Damage was estimated to be 2 percent seaward and 8 percent landward at the conclusion of step 18 (Photos 55 and 56). As anticipated, damage progressed during steps 18-22. At the conclusion of testing (Photos 57-59), the seaward armor from the area between mllw and the back of the crown had incurred 5 percent damage and landward damage had increased to about 25 percent.

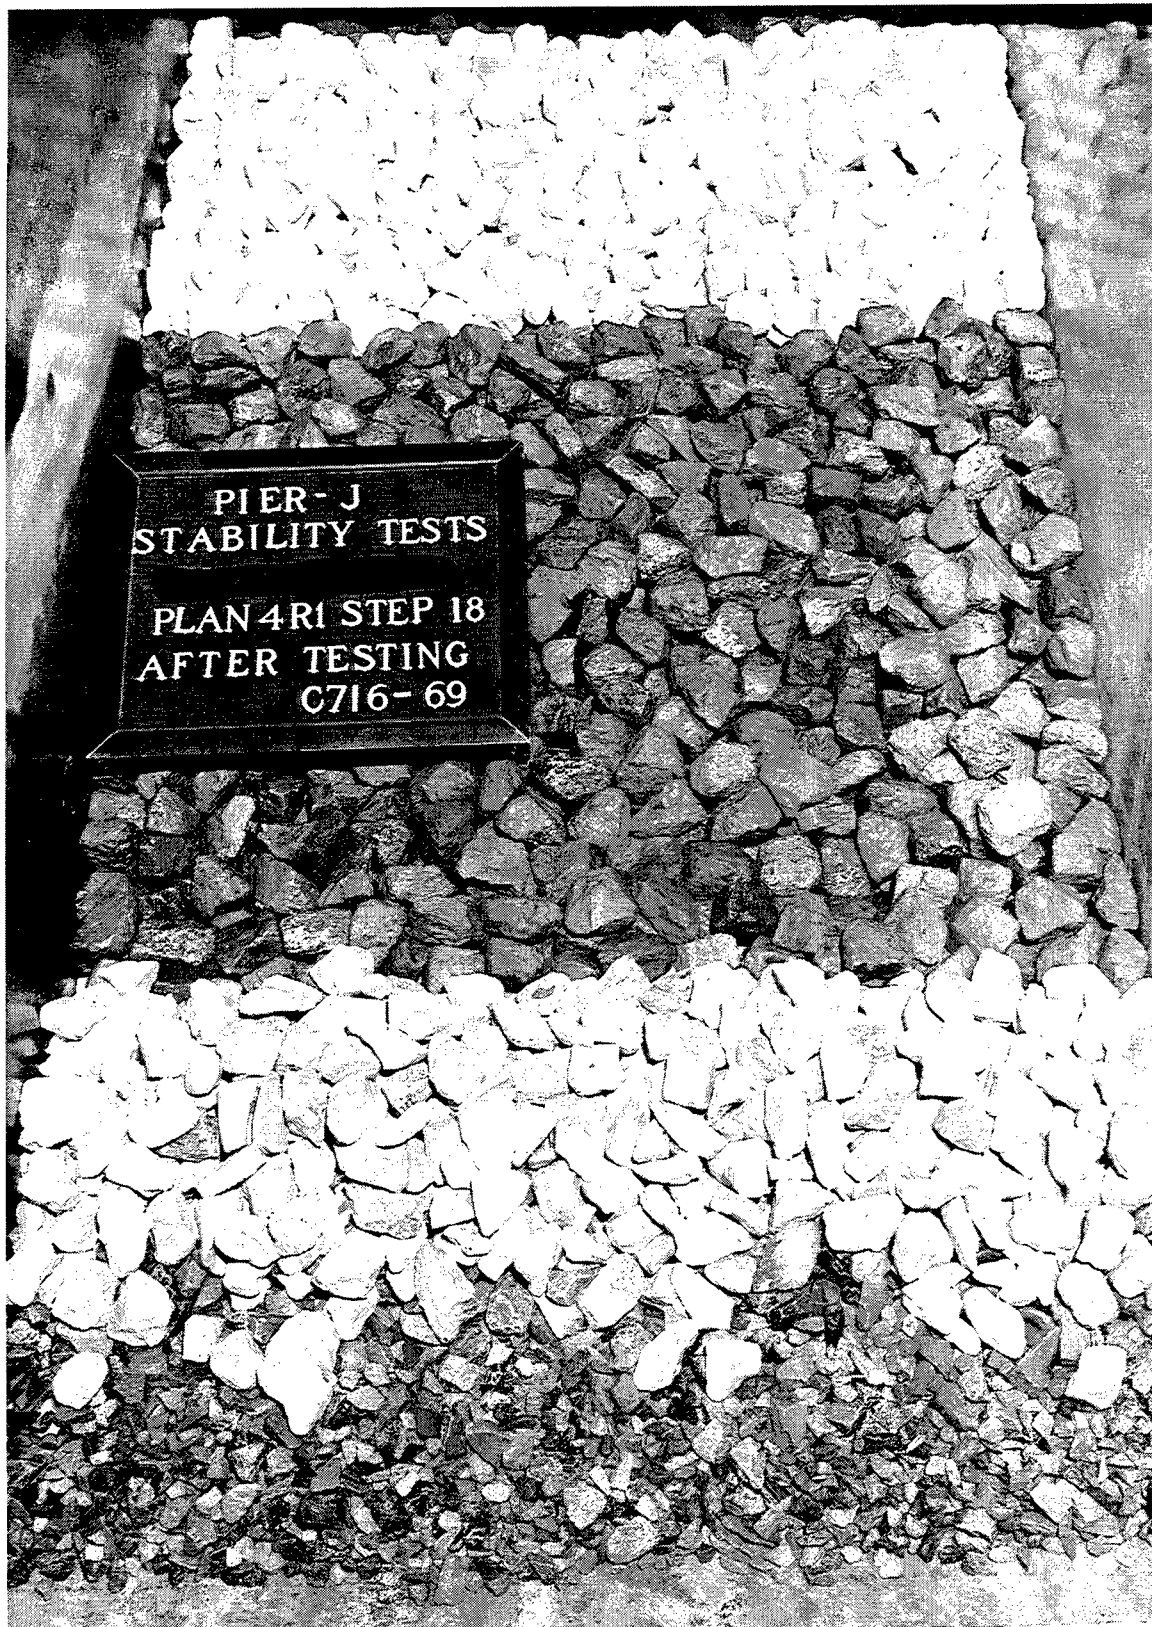
Photo 55. Sea-side view of Plan 4R1 after testing step 18 of Hydrograph 3A

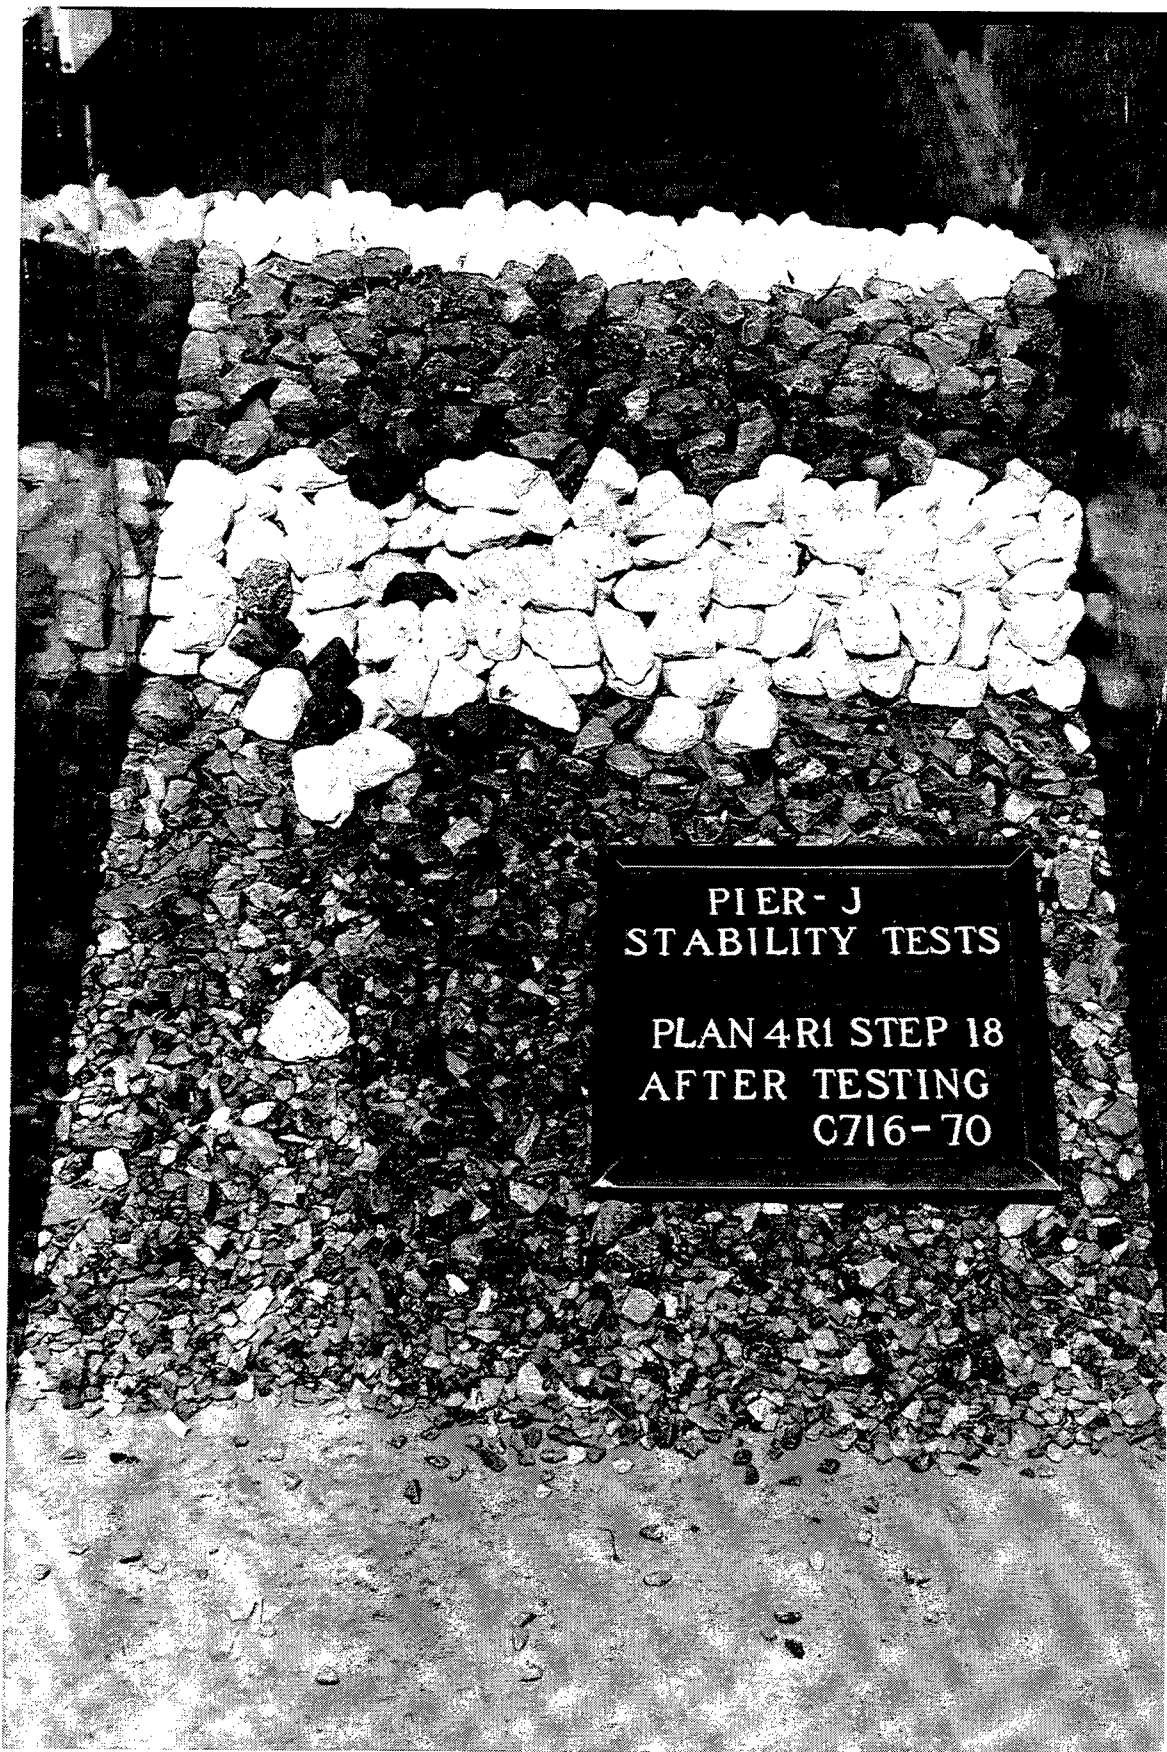
Photo 56. Harbor-side view of Plan 4R1 after testing step 18 of Hydrograph 3A

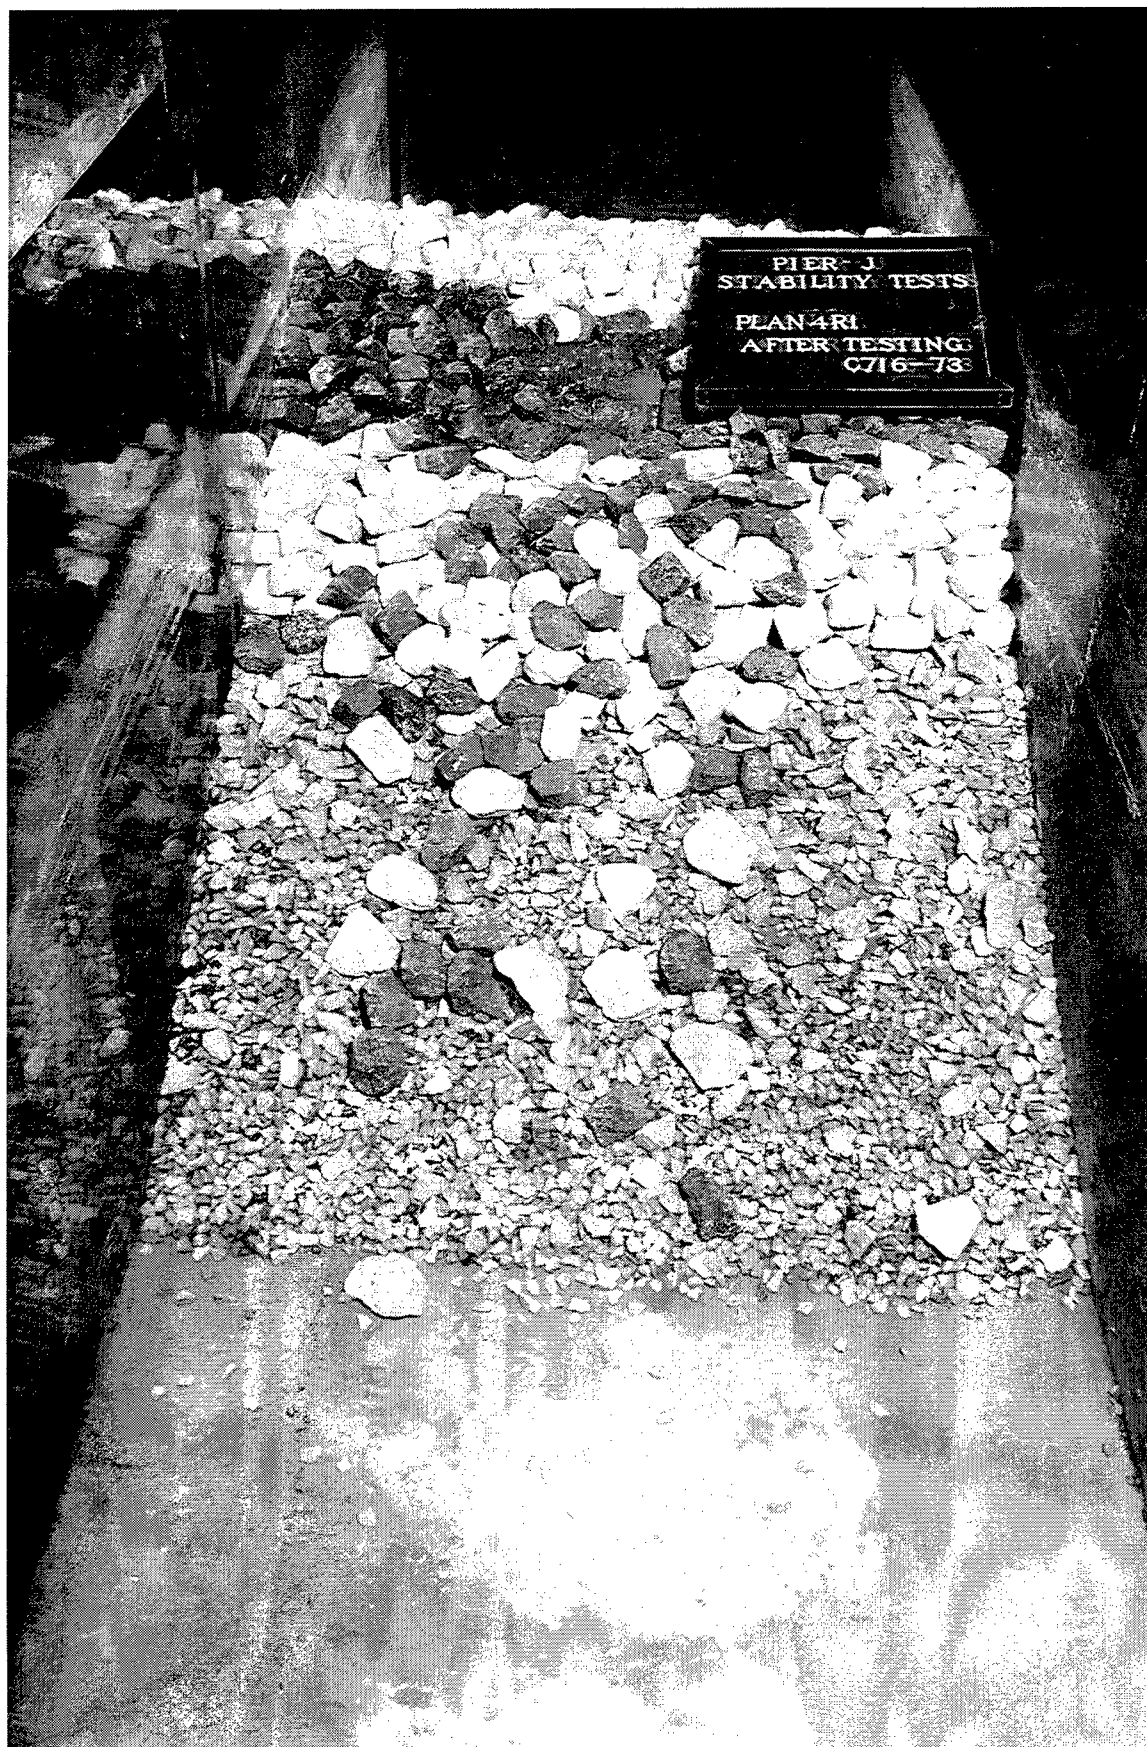
Photo 59. Harbor-side view of Plan 4R1 at the conclusion of testing
